APOLLO 15
30-DAY FAILURE AND ANOMALY LISTING REPORT

MANNED SPACECRAFT CENTER
HOUSTON, TEXAS
SEPTEMBER 1971

1.0 INTRODUCTION

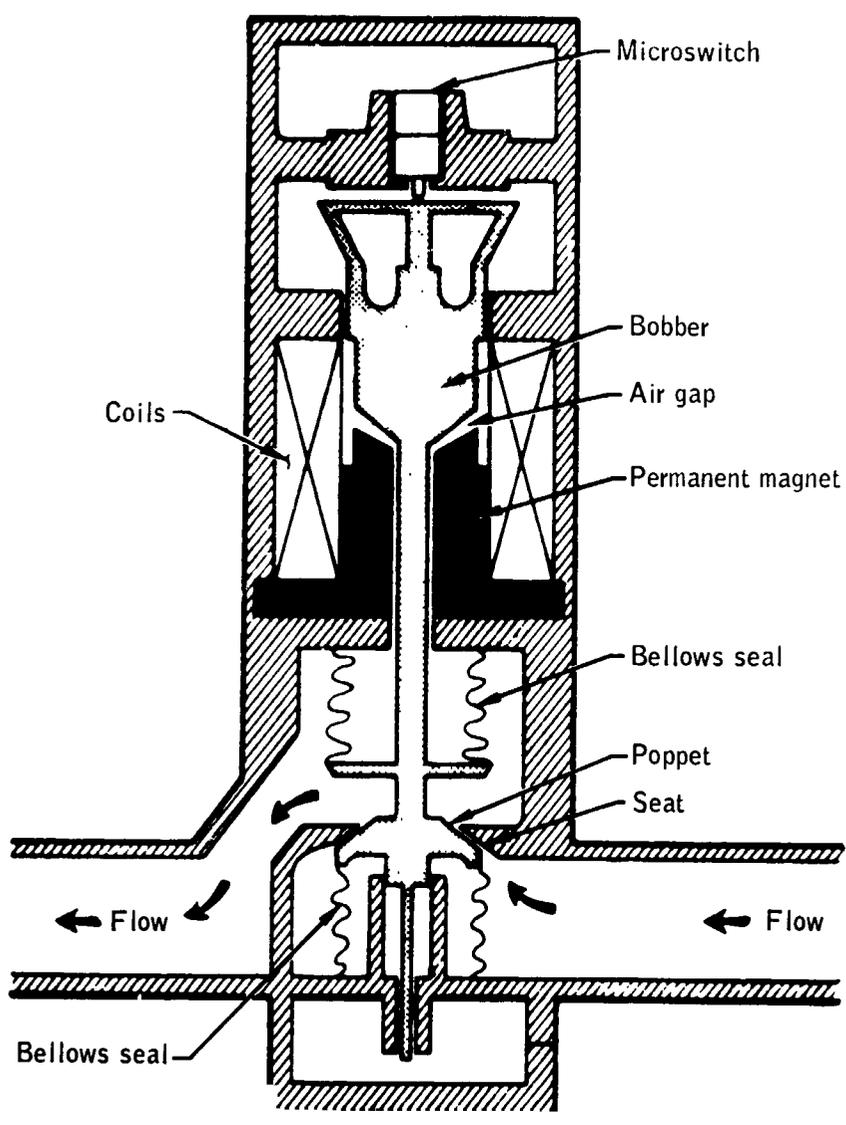
Figure 2-1.- Cross section of reaction control system isolation valve.

At approximately 58 minutes, the quadrant B secondary isolation valve talkback indicated that the valve was closed, and the switch was cycled to open it. At about 1 hour, the crew also reported that both the primary and secondary valves for quadrant D had closed and they were reopened by the crew. At S-IVB separation (approximately 3 hours 23 minutes), all the aforementioned valves closed and were reopened by the crew. Upon jettisoning of the scientific instrument module door, the quadrant B primary valve closed and was reopened.

This type of valve (a magnetic latching valve, shown in fig. 2-1) has, in previous missions, closed as a result of pyrotechnic shocks. Ground tests have shown that the valve will close at a shock level of approximately 80g sustained for 8 to 10 milliseconds. There were no indications of shock levels of the magnitude required to close the valve during boost.

During acceptance testing of one valve for command and service module 117, the latching voltage changed from approximately 13 volts to 3 volts (the lower specification limit is 3.1 volts). Additional testing of the spacecraft 117 valve verified the low voltage condition. Additionally, the valve stroke was proper, thereby eliminating contamination as a possible cause of the problem.

A magnetic latching force test was not performed on the valves after assembly into the system for the Apollo 15 command and service module, as on some previous missions. Tests and analyses are planned to determine if a test can be performed which will verify that the valve latching forces are satisfactory for launch without electrically disconnecting the valves.

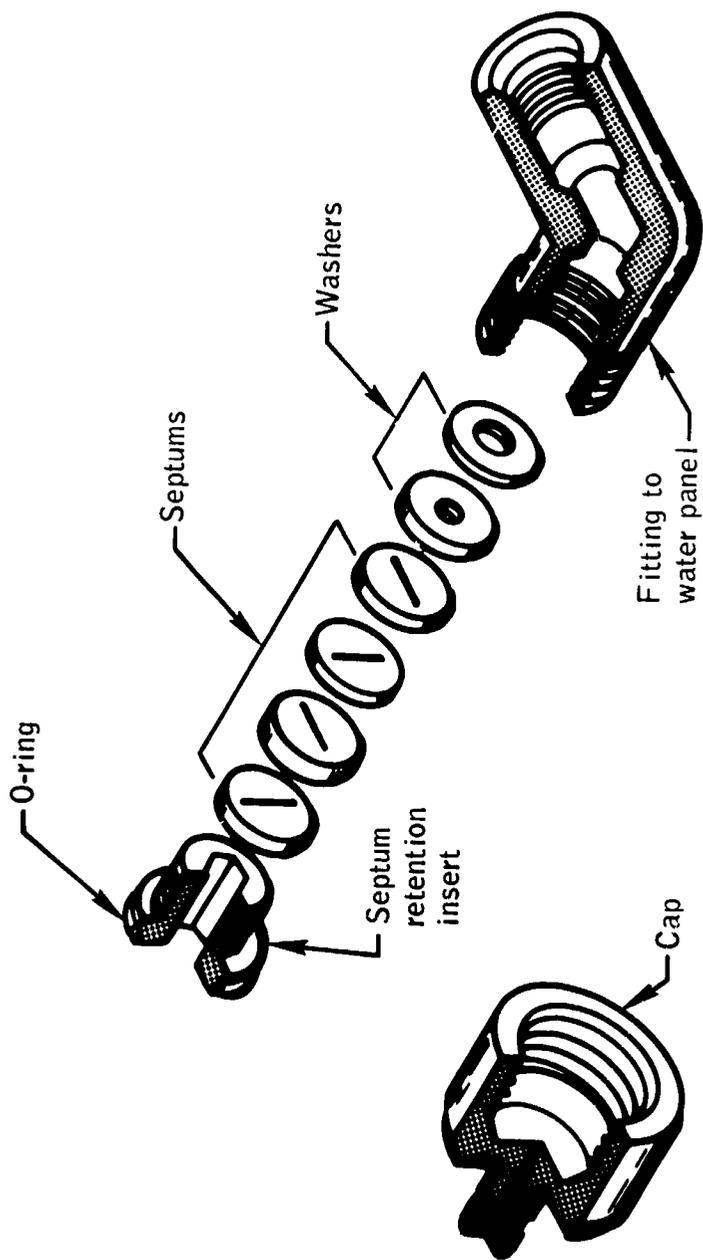
Figure 2-2.- Water panel chlorine injection port.

Minor leakage was noted from the chlorination injection port when the cap was removed to perform the prelaunch water chlorination. The cap was reinstalled and the leak ceased. A leak of approximately 1 quart in 20 minutes also was noted at the chlorine injection port as the crew removed the injection port cap for the third injection at about 61 hours. The crew tightened the port septum retention insert (fig. 2-2) and satisfactorily stopped the leakage. Leakage recurred at about 204 1/2 hours and was corrected.

As the cap is removed, the septum retention insert can back out of the water panel fitting because of the low torque values (5 in-lb maximum) used to squeeze the septums and washers into the fitting. Postflight inspection and dimensional checks of the injection port assembly will be made to determine the reason for loosening of the insert. The use of a spacer and a higher torque value is being evaluated for use on future systems.

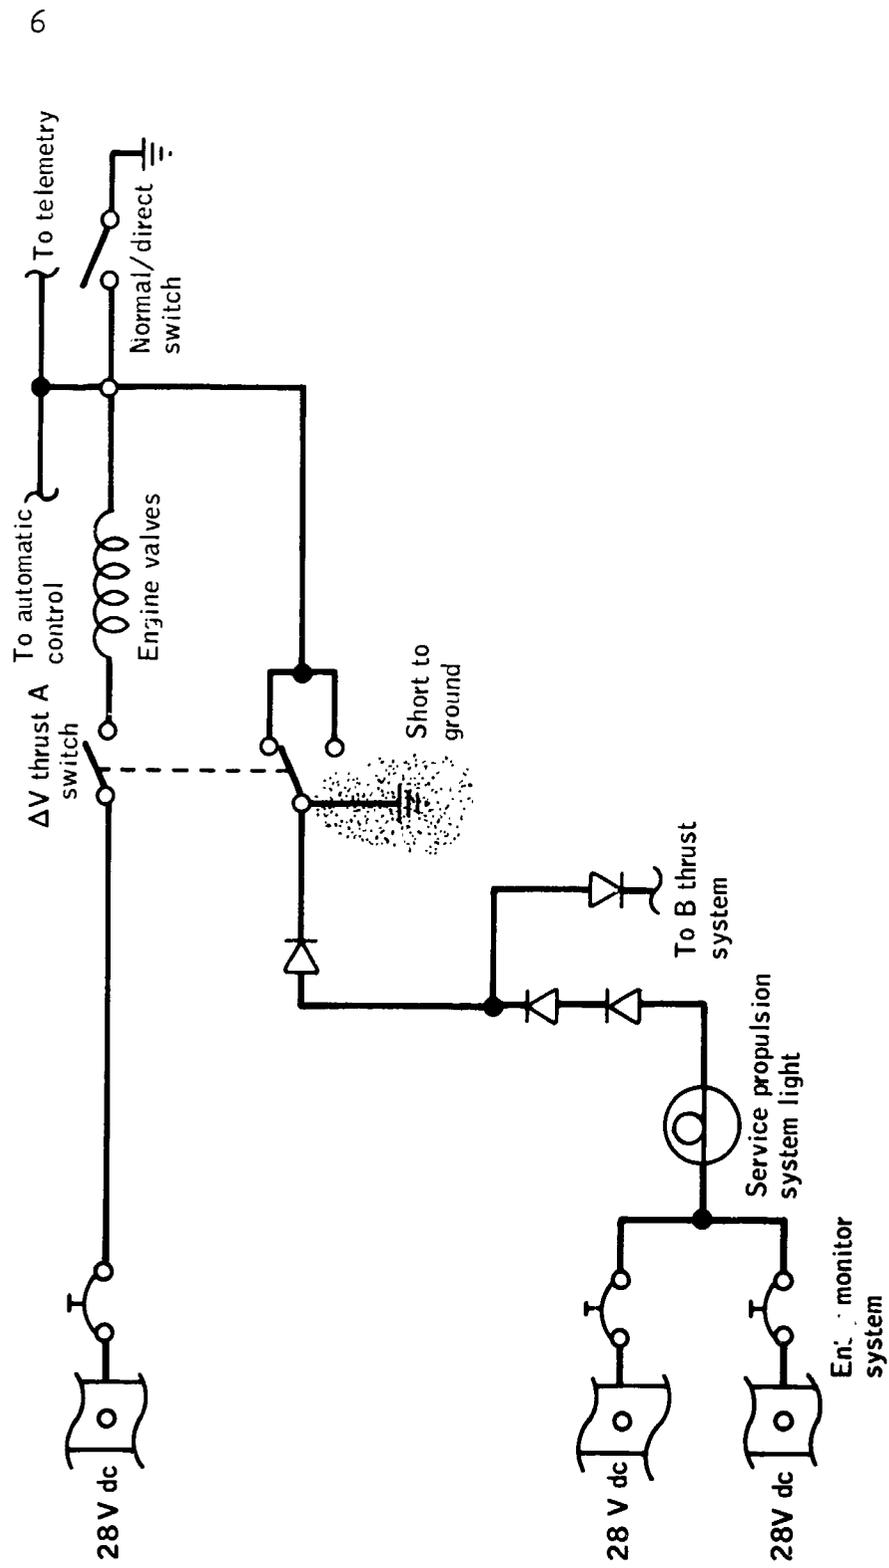
Figure 2-3.- Service propulsion system thrust light circuitry.

A test firing performed at 28:40:30 indicated a short on the ground side of the service propulsion system pilot valve solenoids. The short was further isolated to the system A delta-V thrust switch which was found to be intermittently shorted to ground (fig. 2-3).

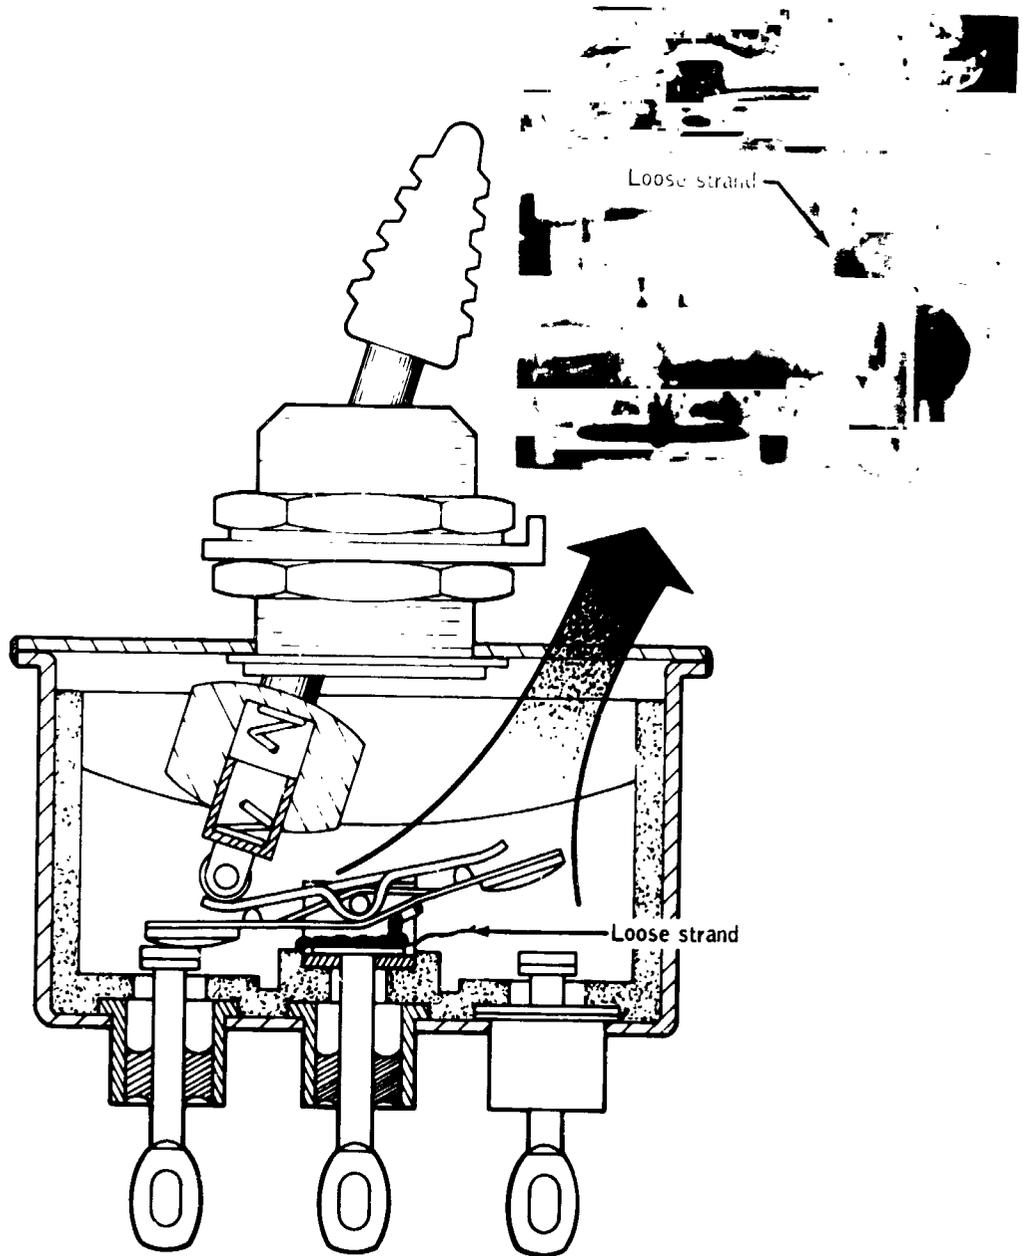
Figure 2-4.- Service propulsion system delta-V thrust switch.

The delta-V thrust switch (fig. 2-4) was shorted to ground both before and after removal of panel 1 from the command module during post-flight testing. The short-to-ground ceased, however, after a change in panel position. The switch was then removed from the panel and X-rayed. The X-rays showed a wire strand extending from the braid strap which was thought to have caused the grounding problem. After switch dissection, an internal inspection verified that a strand extended from the braid strap; however, it did not appear to be long enough to cause a ground at any point within the switch (fig. 2-4). The bracket assemblies (pivot brackets, pigtail braids, and movable contacts) and the plastic liner were removed from the switch. Microscopic examination revealed that a wire strand (approximately 0.060 inch long) was present on the flange on terminal 2 (fig. 2-5). The strand appeared to be attached, but was later moved quite easily.

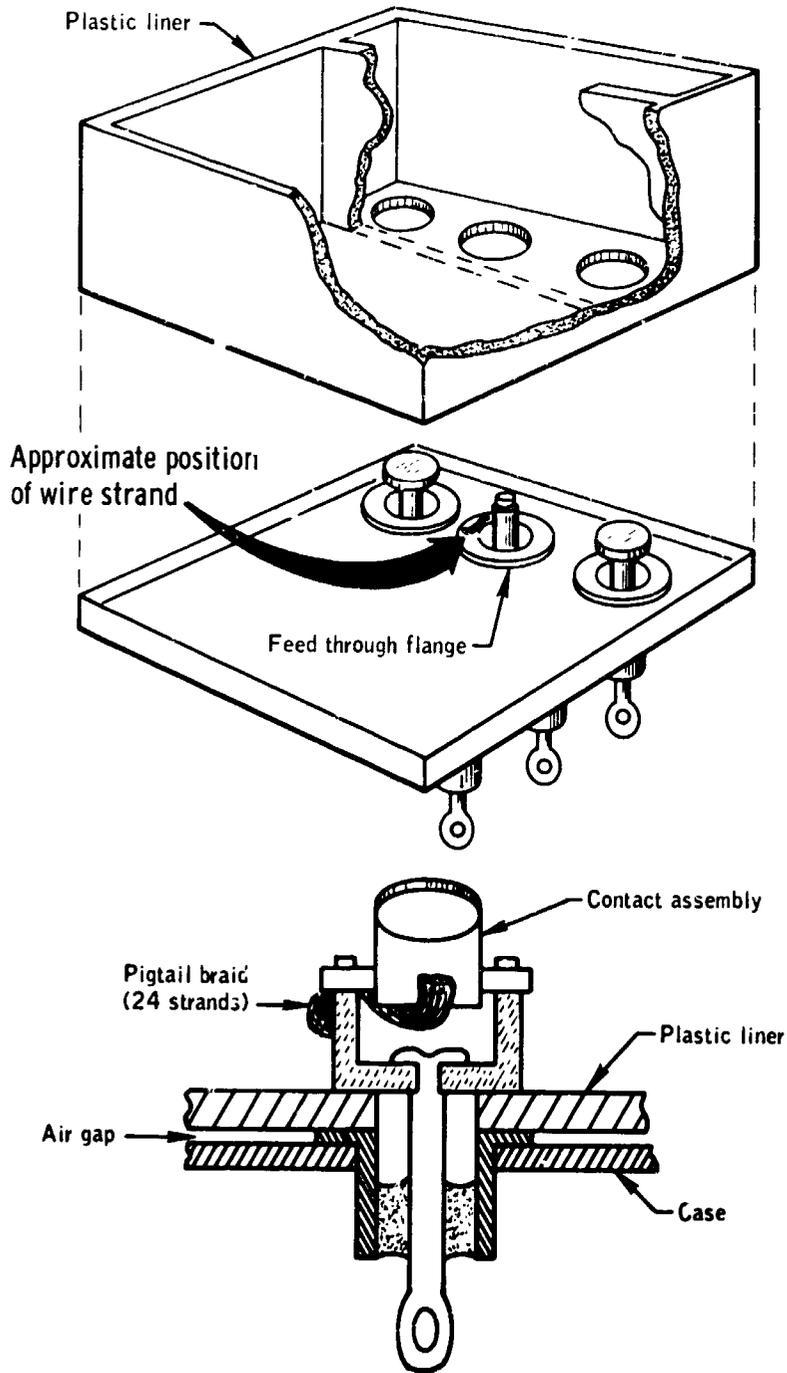
Figure 2-5.- Disassembled service propulsion system thrust switch.

The bottom of the plastic case liner was examined, and showed no evidence of a scratch or deformation conforming to the shape of the wire strand. A sample wire strand was placed on a feed-through flange of a scrap switch unit, and the plastic case liner was pressed on as would occur during normal switch assembly. When the scrap switch was disassembled, an indentation in the plastic case liner was readily apparent. This test indicated that the strand could not have been trapped between the case liner and the flange surface; therefore, it is postulated that it might have been enclosed in the cavity of feed-through terminal 2 (fig. 2-5). The maximum clearance between the interior of the feed-through terminal wall and the terminal itself is 0.032 inch. The wire strand could easily have bridged this distance, and yet is short enough to move quite freely within the feed-through terminal cavity. In fact, the strand subsequently fell into the cavity. The X-rays will be re-examined to determine if this strand can be detected.

The following switches for Apollo 16 were of an earlier series and have been replaced with 4000 series switches:

Switches for crew safety and mission success for Apollo 17 which are not screened switches will also be replaced.

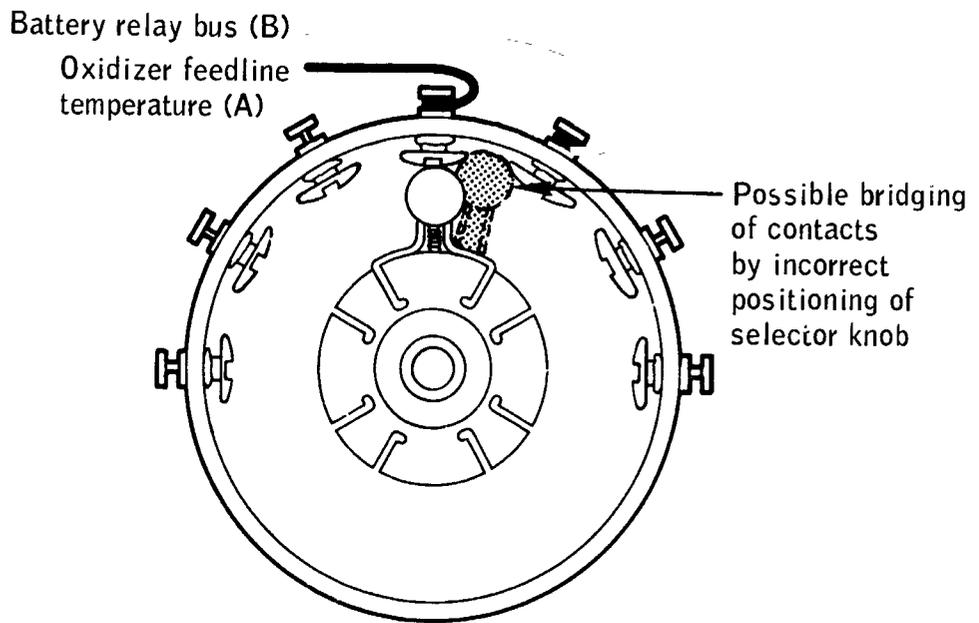
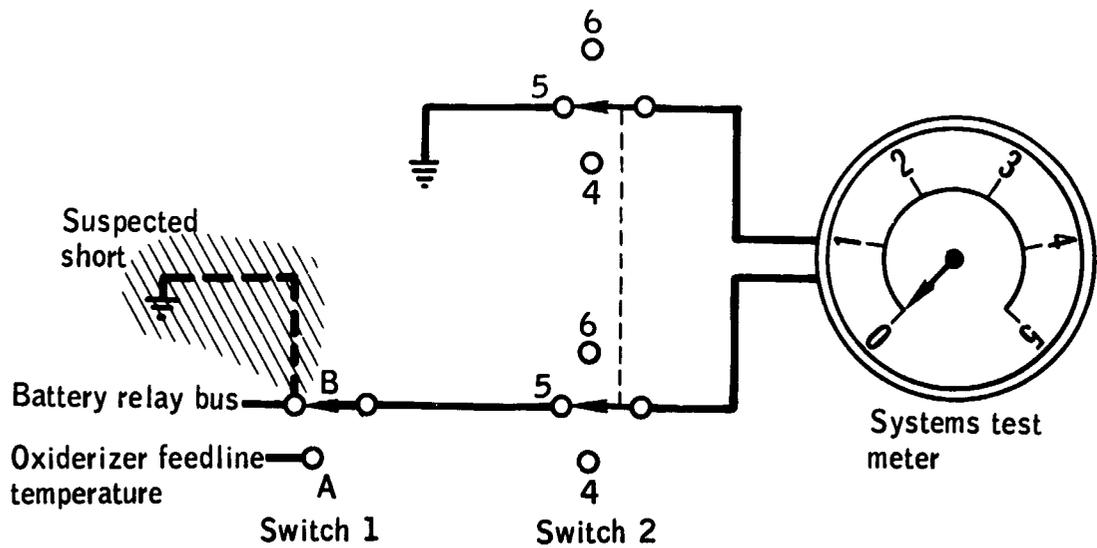
Figure 2-6.- Systems test meter switch.

It was believed that bridging of the adjacent contacts (fig. 2-6) would be the most likely cause of the anomaly. Postflight testing has revealed, however, that bridging of contacts could not reproduce the problem. Analysis indicates that a short of approximately 2.8 kilohms from the battery relay bus contact (fig. 2-6) of the switch to ground will reproduce the reading observed in flight.

The panel containing the systems test meter was removed from the spacecraft and all positions were checked for impedance to ground and to adjacent pins. No abnormal conditions were found. The panel will be installed in the spacecraft and the system tested with the signal conditioning equipment in the circuit. Subsequently, the switch will be removed for teardown inspection if no abnormalities are found.

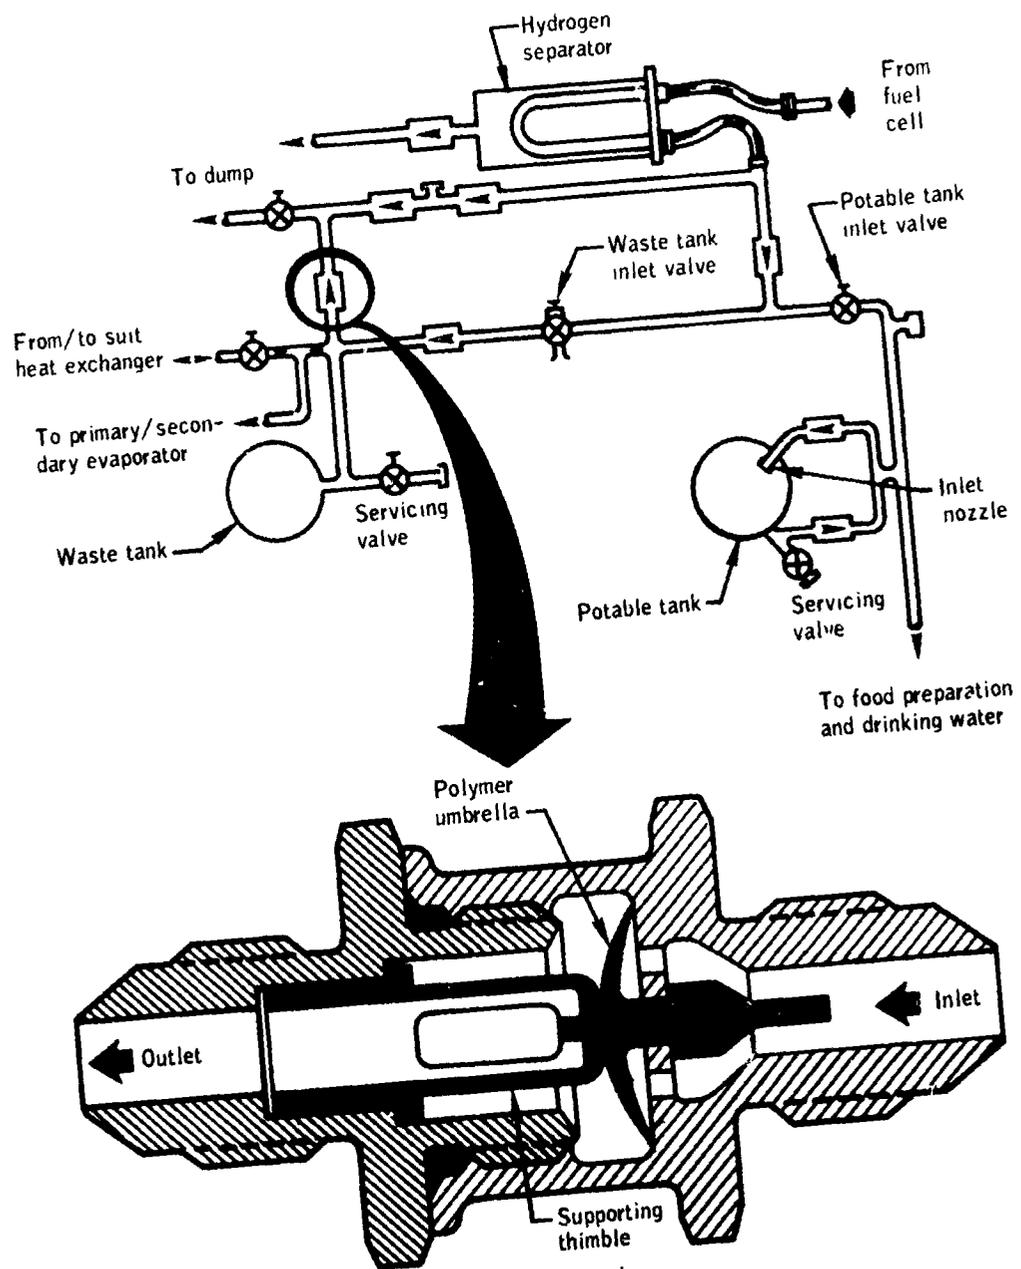
Figure 2-10.- Water management system and failed check valve details.

The potable water tank quantity began to decrease during meal preparation at approximately 277 hours and failed to refill for the remainder of the flight. The waste water tank continued to fill normally and, apparently, accepted fuel cell water for this period. A similar occurrence had been noted earlier, at 13 1/2 hours, when the potable tank quantity decreased, and the tank began to refill only after a waste water dump at 28 1/2 hours. This decrease had been attributed to a closed potable tank inlet valve until the crew verified in their debriefing that the valve had been open during this time. The amount of water drained from the tank verified that the tank instrumentation was reading correctly.

During a postflight fill operation, with water introduced at the hydrogen separator and the waste tank inlet valve closed, the potable and waste water tank filled (fig. 2-10). This shows that the suspect check valve in the waste tank dump leg (fig. 2-10) did not check. The path of least resistance with the check valve leaking would be to the tank with the lower quantity.

The valve will be removed from the spacecraft for further tests and teardown inspection to determine the cause of the malfunction.

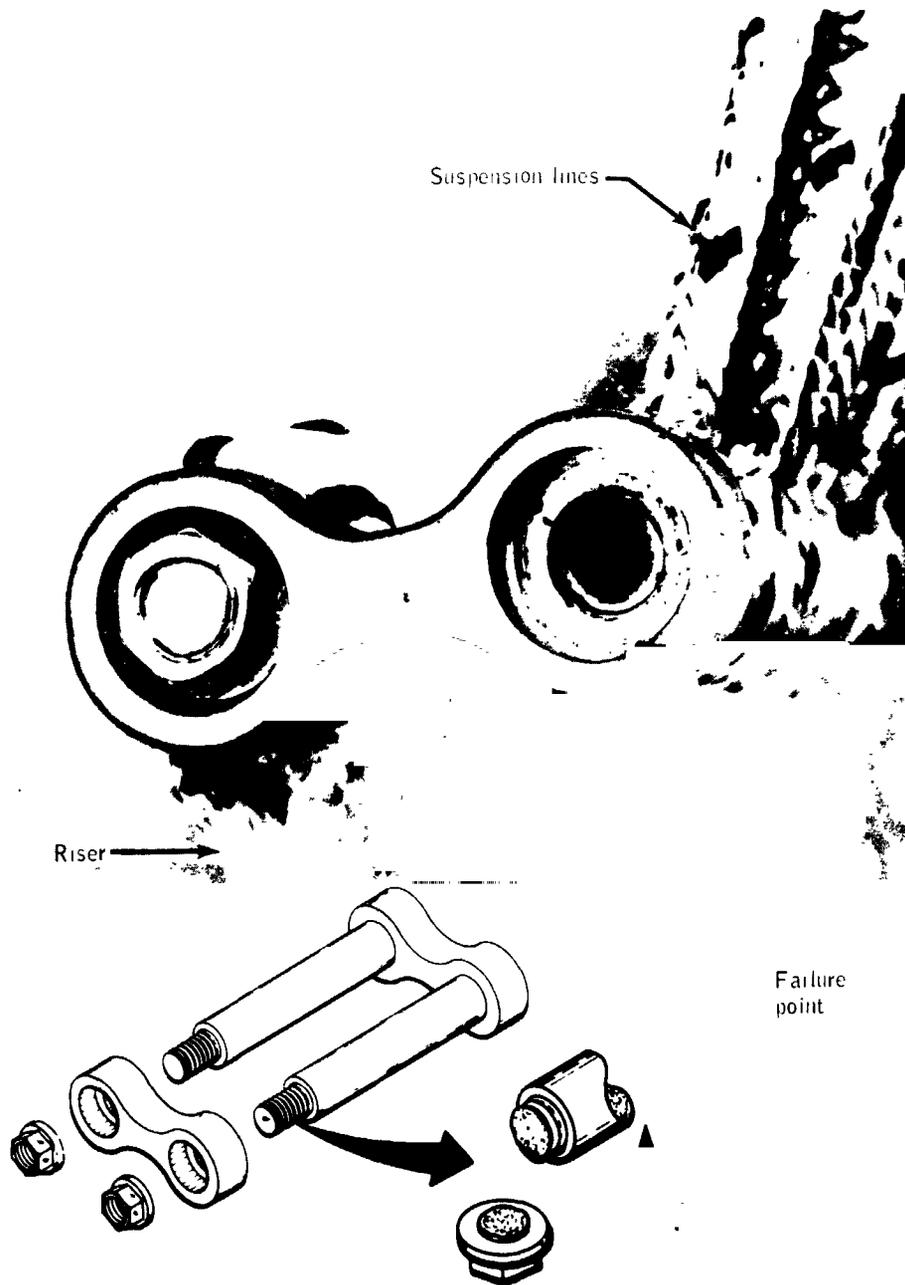
Figure 2-13.- Main parachute connector link failure.

- a. Forward heat shield which was in close proximity to the spacecraft flight path.
- b. Command module reaction control system propellant firing which was just completed.
- c. Broken riser suspension line link which was found on the recovered parachute (fig. 2-13).

The failed link on the recovered parachute implies the possibility of a similar occurrence on the failed parachute. This satisfies the flight data and the visual and photographic data. However, two or three links would have had to separate simultaneously; this item is undergoing further investigation.

Possibilities for the link failure include hydrogen embrittlement, stress corrosion, material defects, manufacturing defects, or assembly problems.

Structural testing and metallurgical examination on the recovered links, and links of different lots, indicate that the hydrogen embrittlement concern was not evident on the flown links. Additionally, all test indications show that saltwater exposure did not induce the cracks, although rusting would be rapid if cracks existed at the time the links were exposed to saltwater. The results indicate the broken link flaw probably occurred prior to saltwater immersion for a reason that is not currently understood.

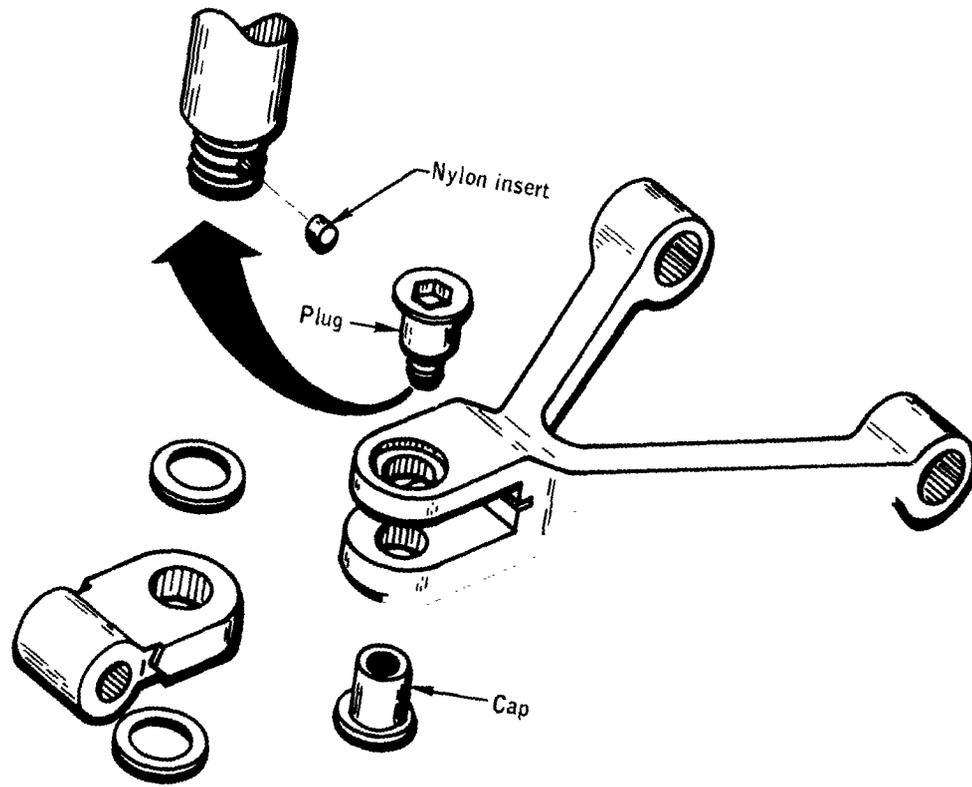
Figure 2-14.- Crew restraint harness connector.

The restraint harness on the right side of both the center and right crew couches came apart during lunar orbit. The assemblies had become unscrewed, but the crew was able to retrieve all the parts except one cap and reassemble the harnesses satisfactorily for landing. The mating plug for the missing cap was held in place with tape.

The plug-and-cap assembly (fig. 2-14), which is part of the universal assembly that attaches the restraint harness to the couch seatpan, separated. (There are a total of six plug-and-cap assemblies on the crew

couch, two per man.) The plug component (bolt) has a nylon insert in the threaded portion that acts as a locking device. Fore and aft rotation of the adjuster link can cause the plug-and-cap assembly to unscrew from each other. The locking insert appears to have marginal engagement.

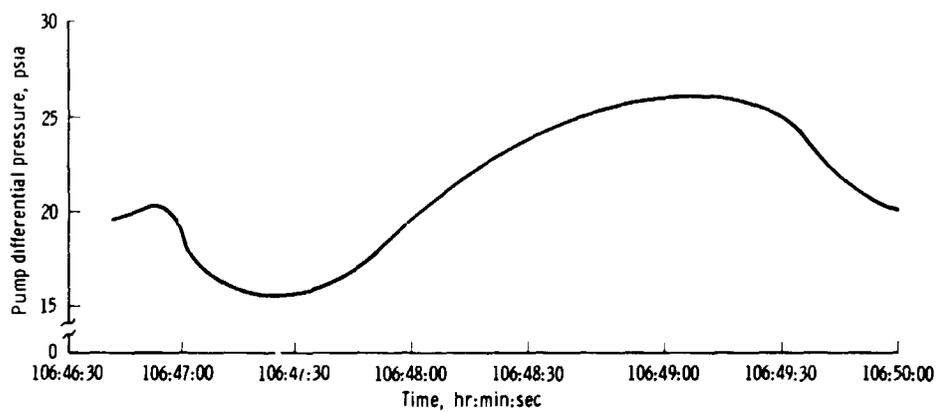
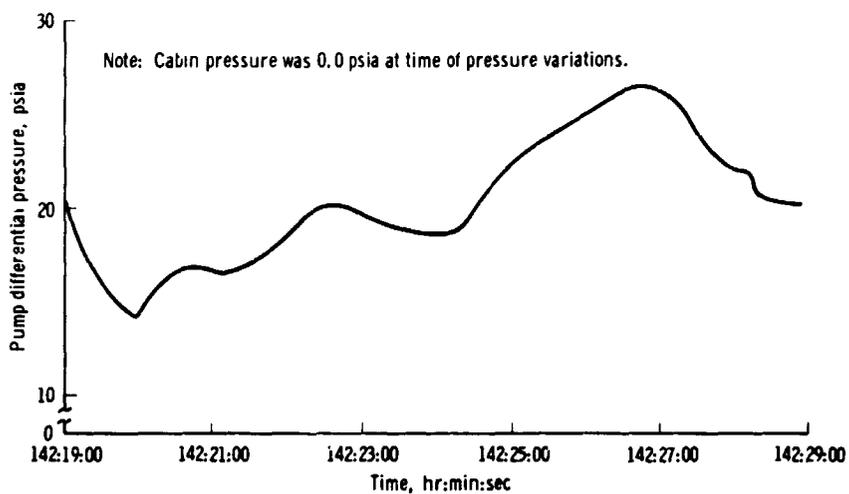
Figure 3-1. - Glycol pump differential pressure variations during extravehicular periods.

Variations were noted in the water/glycol pump differential pressure shortly after the cabin depressurizations for the standup extravehicular activity and the second extravehicular activity. The variations were similar on both occasions. The pressure differential decreased from about 20 psid (normal) to about 15 psid, then increased to about 27 psid and returned to normal (fig. 3-1). The total time for the cycles took 3 minutes (standup extravehicular activity), and 10 minutes (second extravehicular activity). The pump discharge pressure remained relatively stable throughout both periods.

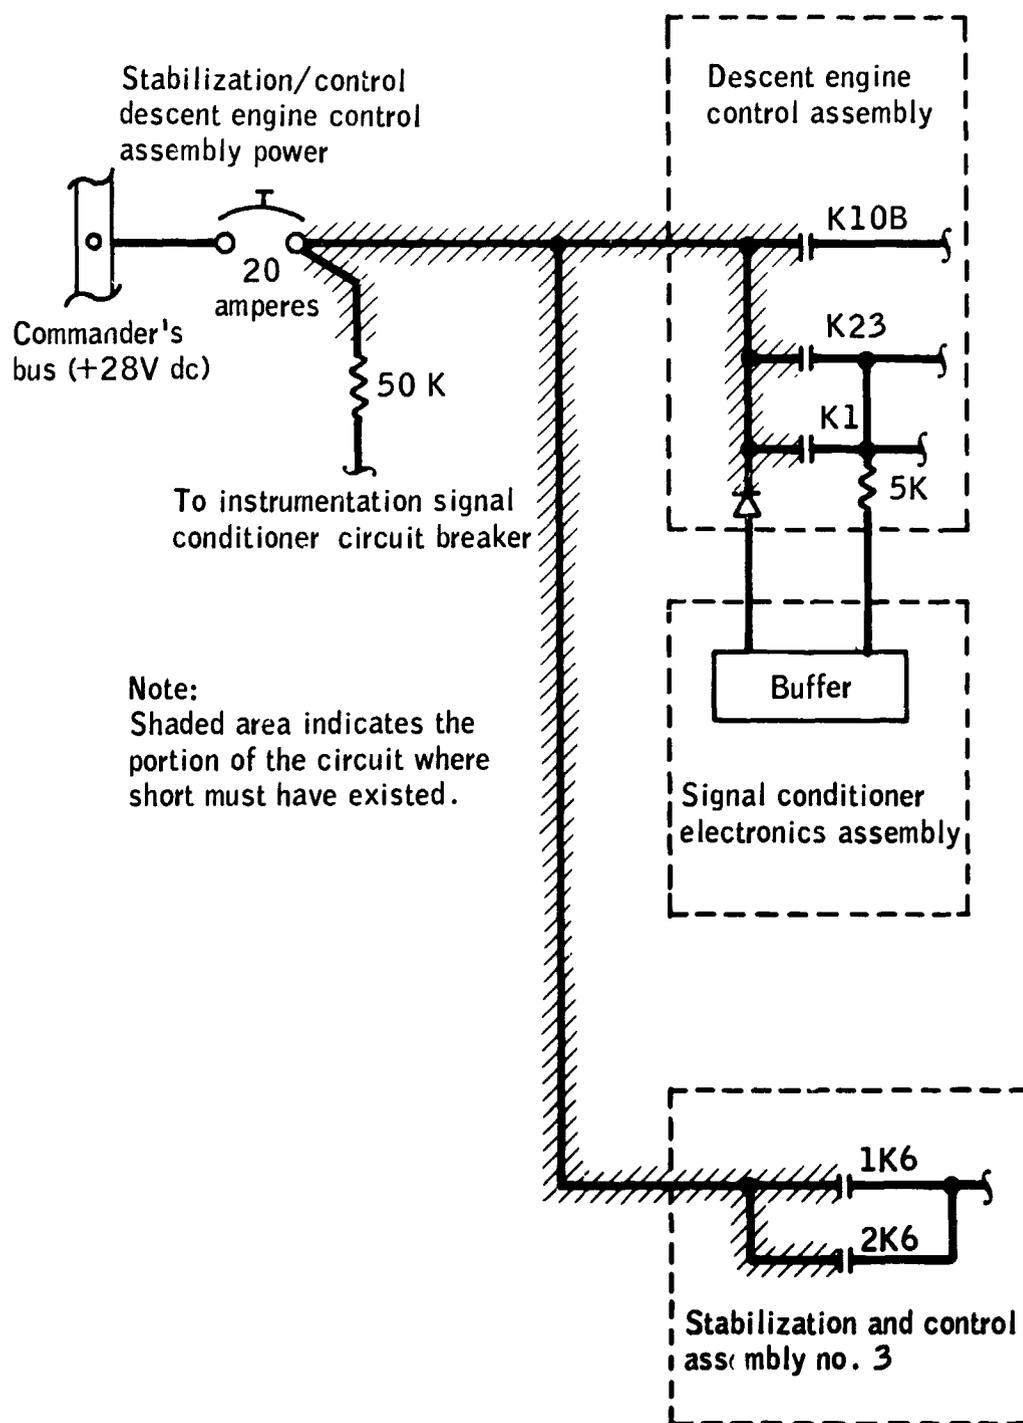
Figure 3-8.- Descent engine control assembly circuit breaker loads.

The descent engine control assembly circuit breaker was found open during an engine throttle check after lunar module separation from the command and service modules. The circuit breaker was then closed and the check was successfully performed.

The crew stated that they may have left the circuit breaker open. If they did not, a short to ground of sufficient magnitude to open the breaker (fig. 3-8) would have to have occurred. To open the 20-ampere breaker, loads of 30 amperes for 1 minute up to 200 amperes for 1 second are required.

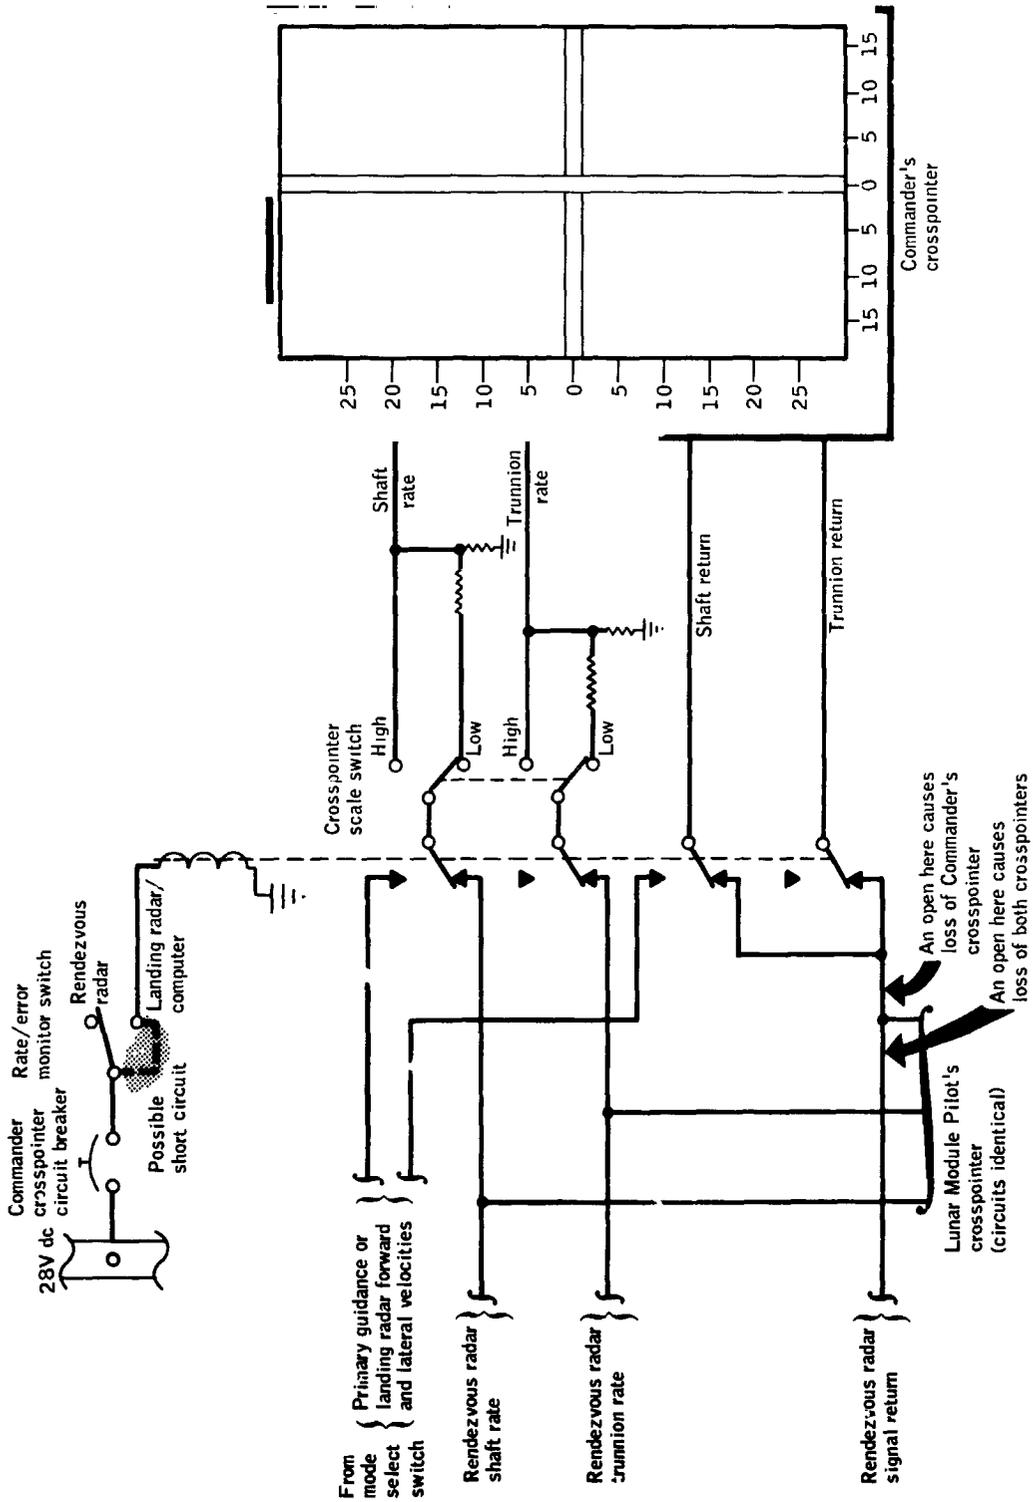
Figure 3-10.- Simplified schematic of crosspointer circuits.

The Commander reported that there was no line-of-sight rate data on his crosspointers during the braking phase of rendezvous. The existence of line-of-sight rates was verified by visually observing the relative position of the command module. The scale switch was verified to be in the low position; however, none of the other switch positions were verified. The power fail light was reported to be off, indicating that the Commander's crosspointer circuit breaker was properly closed.

More than likely, the failure was caused by an open in the ground return wire. Ground tests and checkout may not show this type of failure. If the open is temperature sensitive, a complete vehicle test involving vacuum, temperature, and temperature gradients would be required to insure that failures of this type would not occur in the flight environment.

This type testing is not practical at the vehicle level, consequently, no corrective is planned.

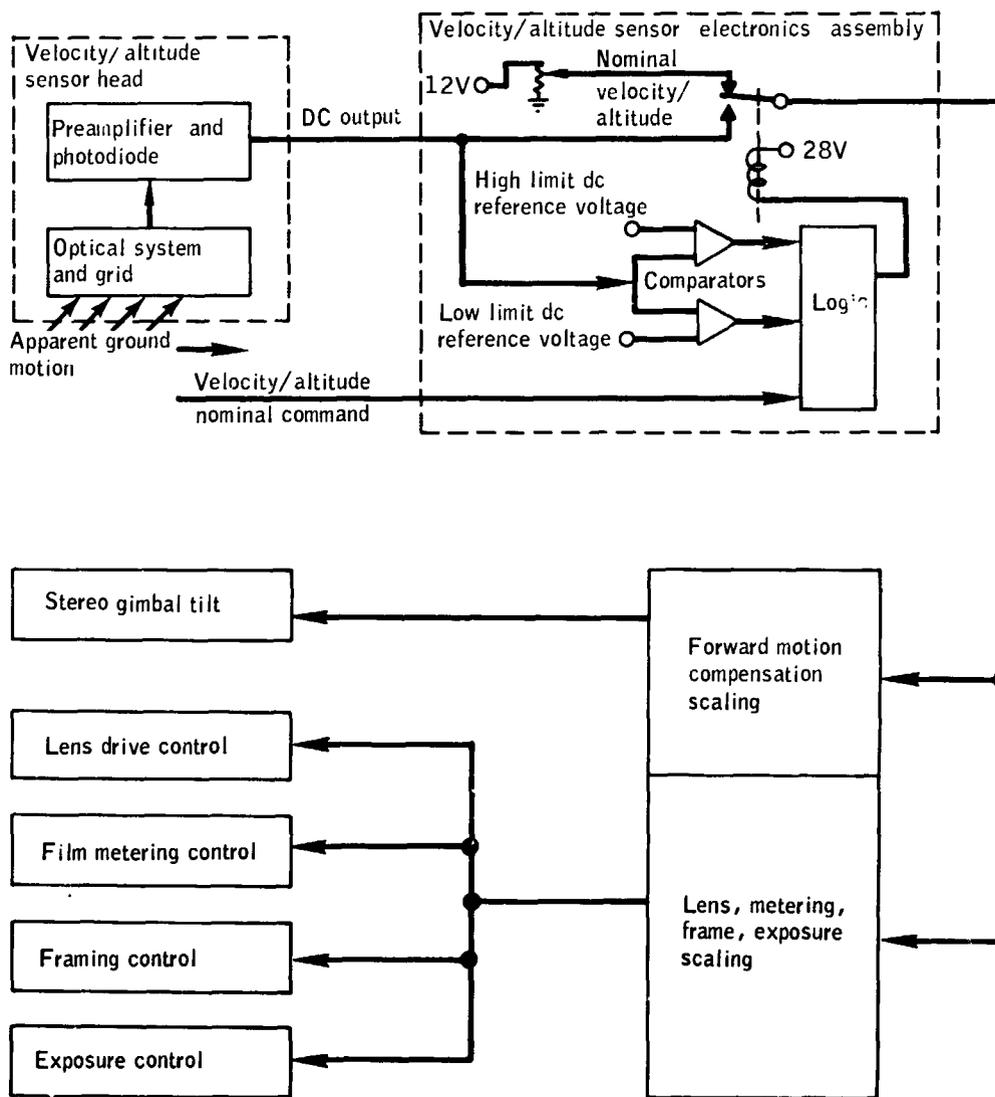
Figure 4-2.- Velocity/altitude output circuitry.

A circuit analysis of the velocity/altitude electronics (fig. 4-2) was performed in an attempt to isolate a component that may have been defective, but the results were negative. Breadboard testing is now in progress. In addition, tests were conducted in which an endless belt of lunar scene photography from Apollo 8 was passed in front of velocity/altitude sensors. Sensors from the prototype and qualification units, and flight unit number 1 were used. By varying the illumination level, sensor performance somewhat similar to the Apollo 15 anomaly could be obtained. Although the anomalous performance during the mission occurred with lunar scenes of both high and low contrast and high and low illumination levels, the possibility of a basic error in the velocity/altitude sensing concept is not being discounted. Therefore, further simulations utilizing Apollo 15 panoramic camera pictures are to be performed.

A manual override of the velocity/altitude sensor on the remaining flight units is being considered. By utilizing a three-position switch, two preselected velocity/altitude ratios could be provided, as well as the automatic function.

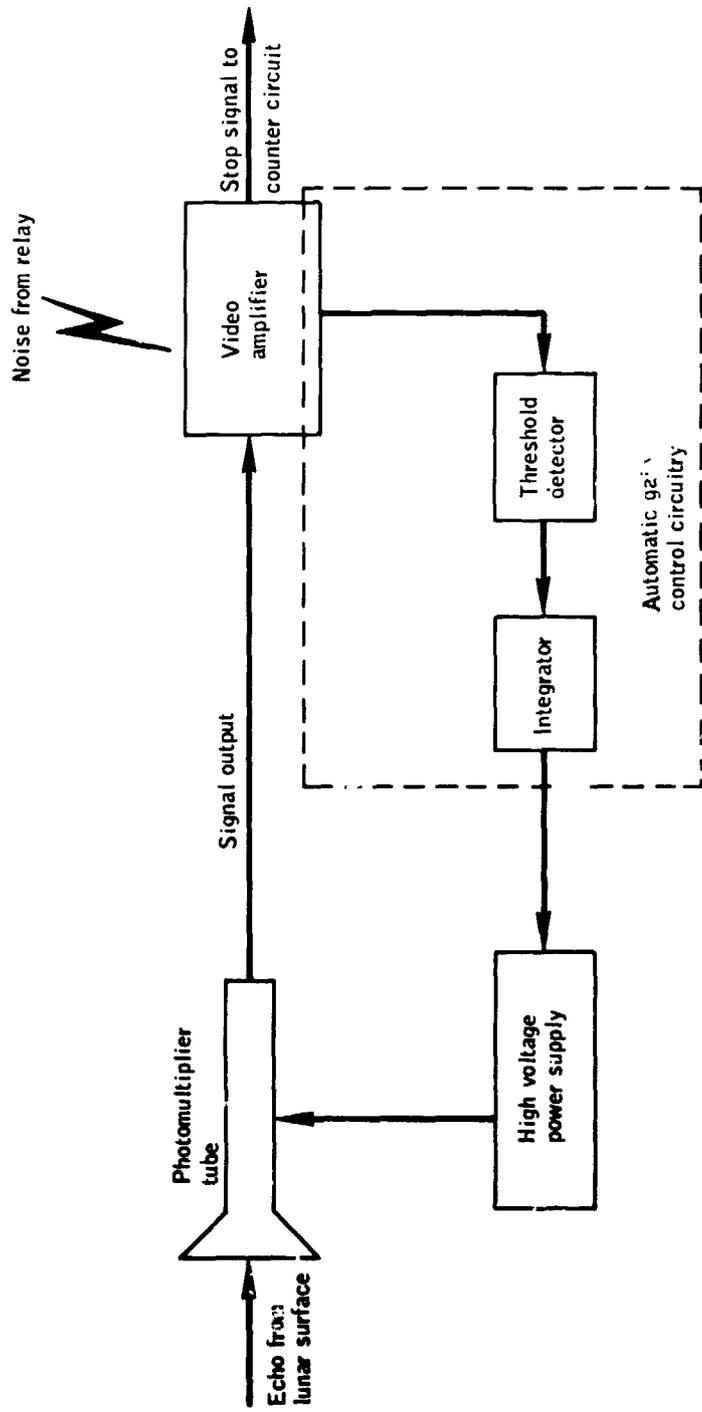
Figure 4-5.- Laser receiver circuitry.

It is suspected that the audible "buzz" is accompanied by electromagnetic interference that is coupled into the video amplifier in the laser receiver (fig. 4-5). The video amplifier is a principal element in the automatic gain control circuit which controls the output of the photomultiplier tube power supply. The electromagnetic interference from the relay can thereby result in the automatic gain control holding

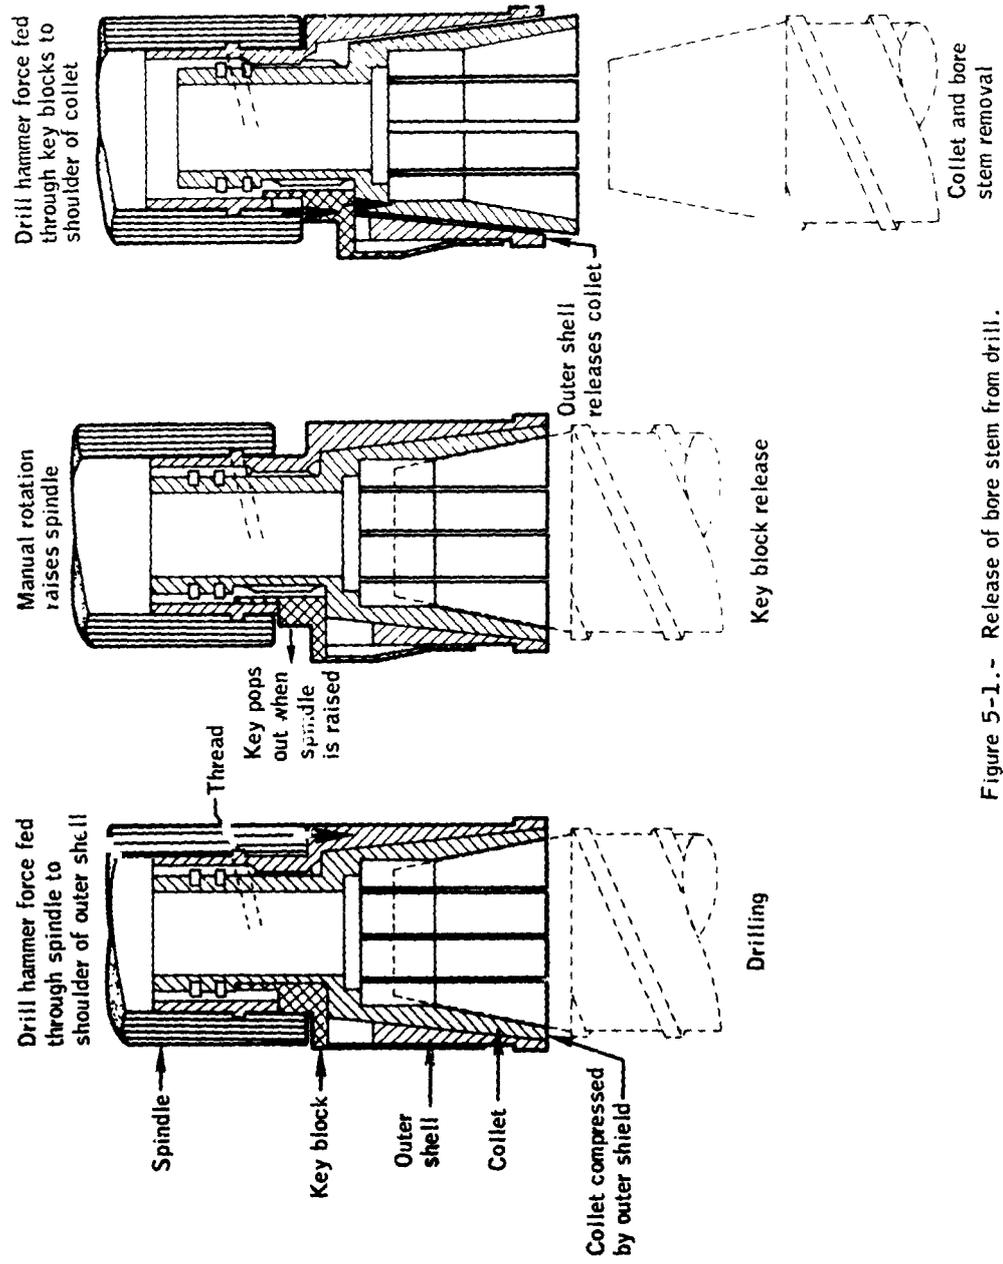
Figure 5-1.- Release of bore stem from drill.

Of the bore stem releases accomplished in the two heat flow experiment probe locations, most of them were with the gloved hand holding the bore stem, and the collet release mechanism functioned properly.

An improved procedure, as well as possible modifications, for contingency bore-stem holding are being investigated.

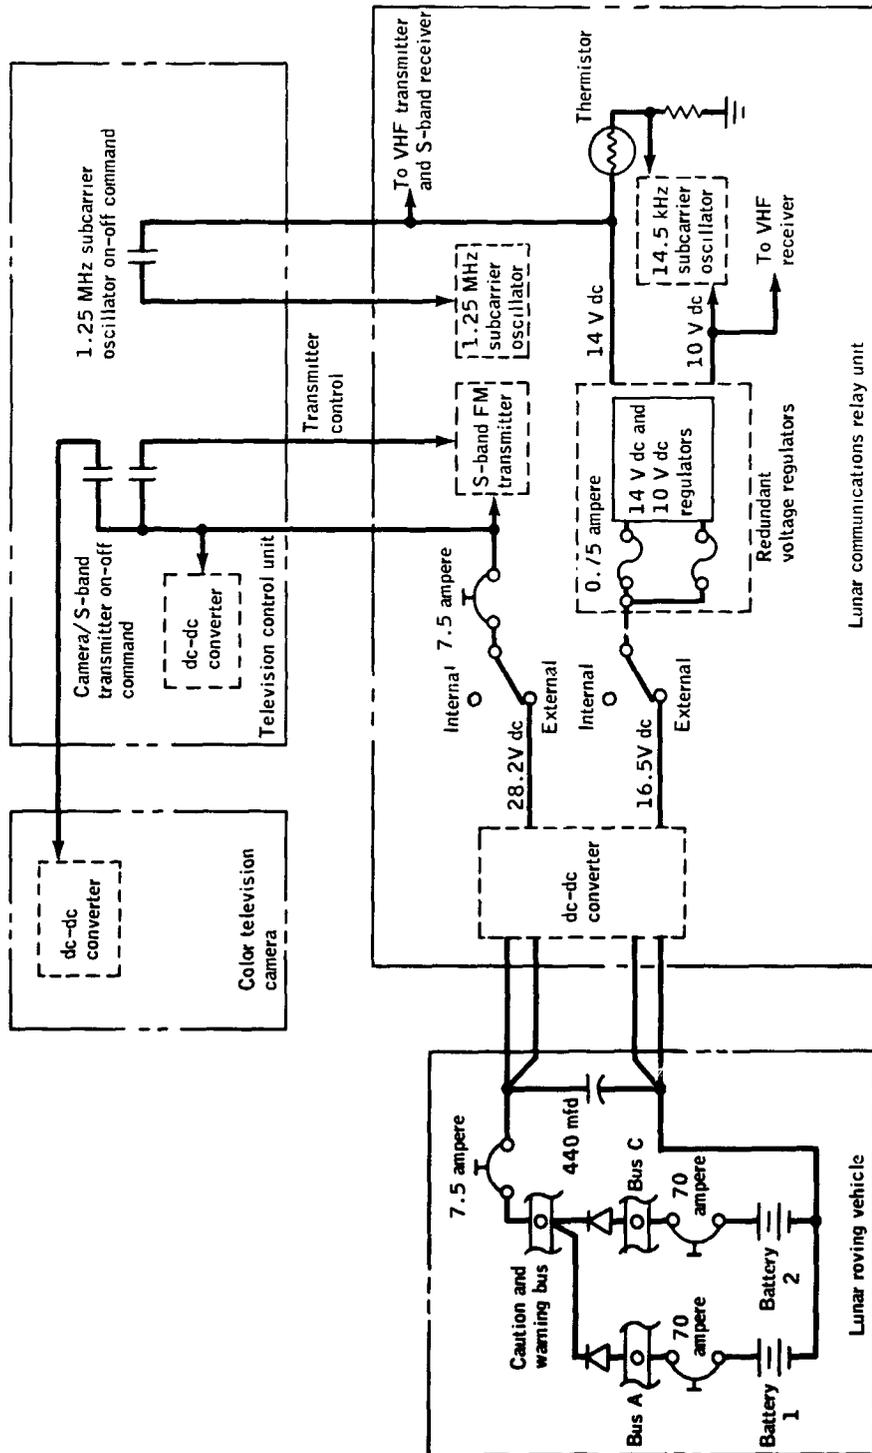
Figure 6-3.- Lunar roving vehicle/lunar communications relay unit/ground controlled television assembly power distribution.

The lunar communications relay unit downlink signal was lost at 211:30:08, about 40 hours after lunar module ascent. The lunar communications relay unit operates on internal battery power during the extravehicular traverse but, just prior to the end of the third extravehicular

In laboratory tests, numerous types of faults were induced into the lunar communications relay unit developmental unit and associated ground-controlled television assembly and lunar rover vehicle interfaces to determine whether the transient characteristics of the flight signal could be duplicated. The fault which duplicated the flight signal was the opening of the lunar roving vehicle power line prior to the 440-microfarad capacitor (figs. 6-2 and 6-3). The Tests, show that the decay time of the lunar communication relay unit 28-volt and 14-volt power is increased by discharge of the 440-microfarad capacitor. Other induced faults resulted in shorter power decay times, affecting the received signal accordingly. The temperature measurement output (see thermistor in fig. 6-2) is proportional to the decay in 14-volt power. Consequently, the 6-percent decay of the flight temperature signal corresponds to a 1.4-volt decay. This characteristic was exactly duplicated when the lunar roving vehicle power line was opened. The 28-volt power decayed to 21.8-volts dc when the 14-volt power decayed to 12.6-volts. The RF transmitter power at this voltage will be decreased by 6.4 dB, which accounts for total signal loss at this exact time since the ground receiver would be below its threshold. This characteristic was also duplicated with the flight data when the lunar

roving vehicle circuit was opened. In summary, the test shows either the 7.5-ampere circuit breaker popped, or a wire opened upstream of the 440-microfarad capacitor.
